# Manhole Inspection Summary

# Manhole # S19W\_\_012MH

Insp Date: **6/27/08 9:43 AM**

**Location** Address: **2345 somerworth st**

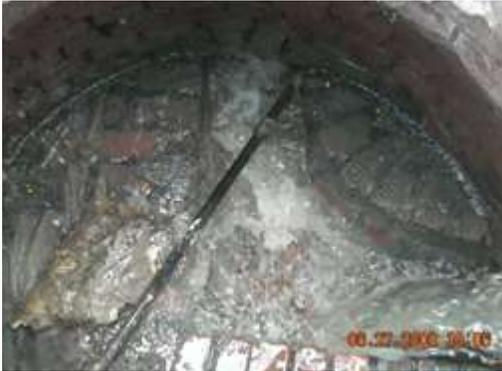
Defect 3

Condition:  Sound  Cracked  Root Intrusion  Deteriorated  Leaks  **Debris**

**Evidence Of Surcharge** Depth: **1.5** (ft.)  Active Surcharge Present

debris in channel, surcharge evidence

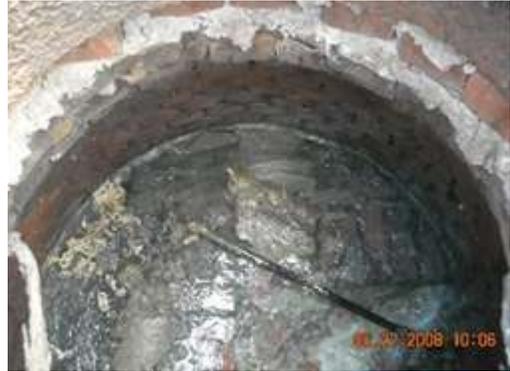
Defect 2

debris on bench

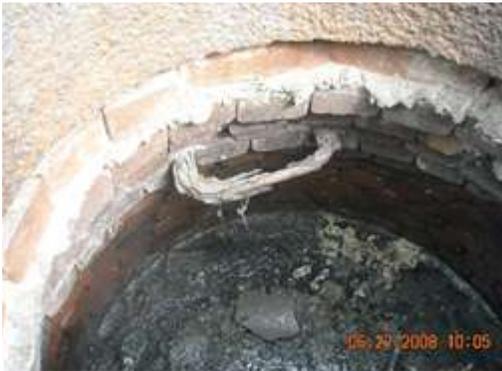
Defect 1

Condition:  Sound  **Cracked**  Root Intrusion  Loose Brick  Deteriorated

Count: **1** Missing: **0**  **Corroded**

corroded step, chimney cracks

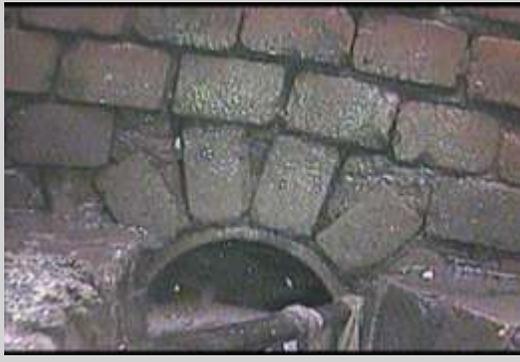
12 O'Clock Outflow

8 in. Circular Gravity Sewer  
Pipe Out @ 12 O'Clock

Pipe Height: **8.4** (in.) Rod and Bar (Angled)  
Pipe Material: **Clay**  Pipe Lined  
Invert Depth: **4.11** (ft.) Flow Characteristics: **Fast**  
Deposits:  None  **Mud**  **Sludge**  **Debris**  Grease  
Silt Depth: **3** (in.) Deposits Extent: **Medium**  
Infiltration: **None** Pipe Seal Cond: **Sound**

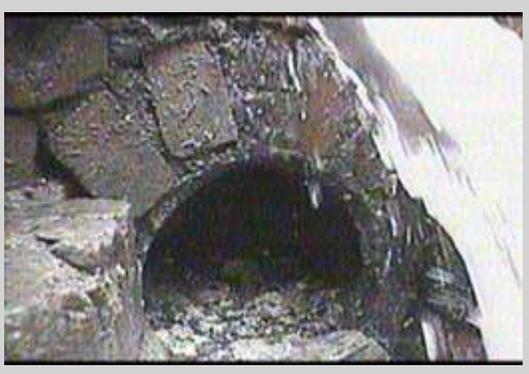
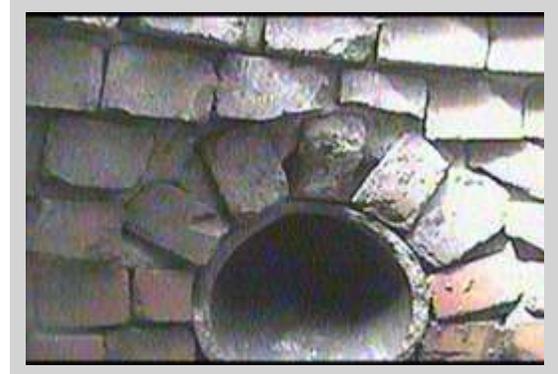
3 O'Clock Inflow

8 in. Circular Gravity Sewer  
Drop In @ 3 O'Clock

Pipe Height: **8.4** (in.) Rod and Bar (Angled)  
Pipe Material: **Clay**  Pipe Lined  
Invert Depth: **2.74** (ft.) Flow Characteristics: **Turbulent**  
Deposits:  None  **Mud**  **Sludge**  **Debris**  Grease  
Silt Depth: **3** (in.) Deposits Extent: **Medium**  
Infiltration: **Evidence** Pipe Seal Cond: **Cracked**

Drop: **Outside** **Rod and Bar**  
Angled: **Yes** Reading: **2.80** (ft.)  
Inv Depth: **3.80** (ft.)  
Drop Condition: **Clogged**
